Manhole Inspection Summary

Manhole # S41A__011MH

Insp Date: **11/14/08 12:18 PM**

Location Address: **1235 treelef ct**

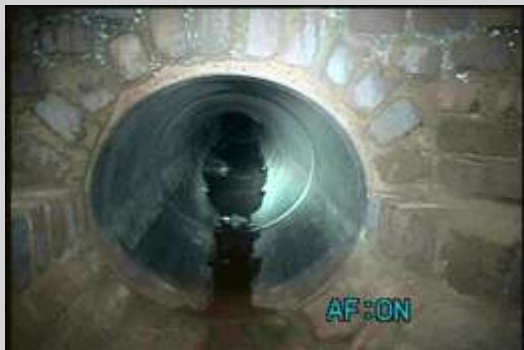
12 O'Clock Outflow

18 in. Circular Gravity Sewer
Pipe Out @ 12 O'Clock

Pipe Material: **Clay** ☐ Pipe Lined

Invert Depth: 7.80 (ft.) Flow Characteristics: **None**

Deposits: ☒ None ☐ Mud ☐ Sludge ☐ Debris ☐ Grease

Infiltration: **None** Pipe Seal Cond: **Unknown**

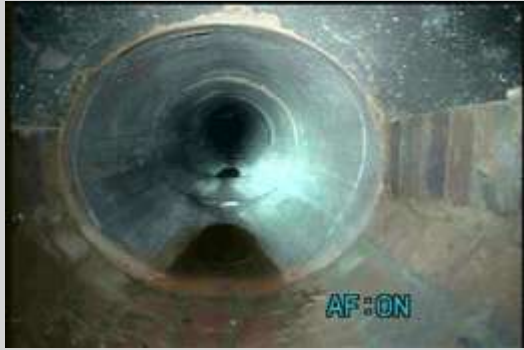
6 O'Clock Inflow

18 in. Circular Gravity Sewer
Pipe In @ 6 O'Clock

Pipe Material: **Clay** ☐ Pipe Lined

Infiltration: **None** Pipe Seal Cond: **Unknown**
